PERFORMANCE CHARACTERISTICS OF THE DEEP SPACE 1 FLIGHT SPARE ION THRUSTER LONG DURATION TEST AFTER 21,300 HOURS OF OPERATION

Anita Sengupta, John R. Anderson, and John R. Brophy
Jet Propulsion Laboratory
California Institute of Technology
4800 Oak Grove Drive
Pasadena, CA 91109
818-393-3430
Anita.Sengupta@jpl.nasa.gov

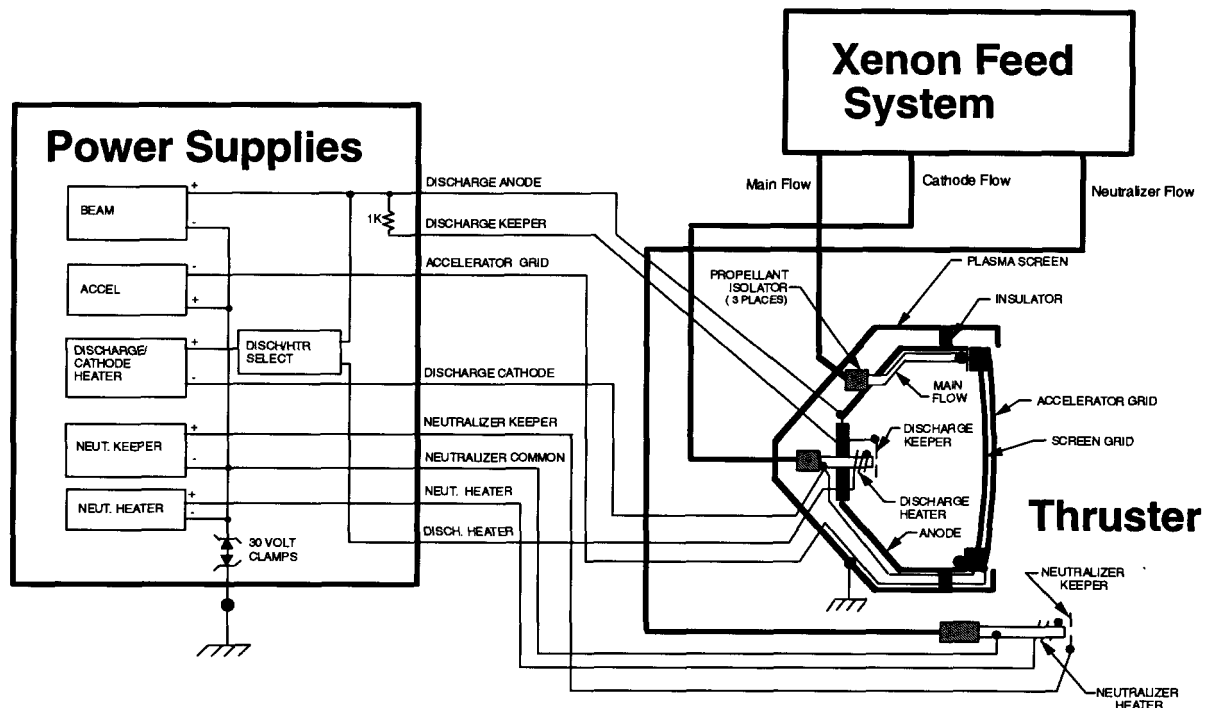
A schematic diagram of the 30-cm-diameter NSTAR flight thruster is shown in Fig. 1. The thruster is comprised of four major functional components, the discharge cathode, discharge chamber, ion optics (accelerator) assembly, and the neutralizer assembly. An ion thruster operates by ionizing neutral xenon gas in the discharge chamber by electron collision with neutrals. The positively ionized xenon propellant is then focused and electro-statically accelerated through a two-grid electrode system, the ion optics. The neutralizer cathode acts as a plasma bridge between the neutralizer and beam; supplying electrons to charge neutralize the ion beam.¹

The FT2 thruster employs a spun titanium discharge chamber, with a three-ring cusp magnetic field design. The discharge cathode, located at the rear of the chamber, is the source of electrons to the discharge chamber. The magnetic field is used to improve ionization (propellant utilization) efficiency by increasing the residence time of electrons in the discharge chamber. By forcing electrons to gyrate around the magnetic field lines, before they are collected by the anode, the number of ionizations is greatly increased. The discharge chamber is enclosed in a perforated plasma screen to prevent beam neutralizing

Fig. 1 Schematic of FT2

electrons from reach high-voltage surfaces. The two-grid molybdenum optics assembly is located downstream of the discharge chamber. Details on the thruster design can be found in reference [1].

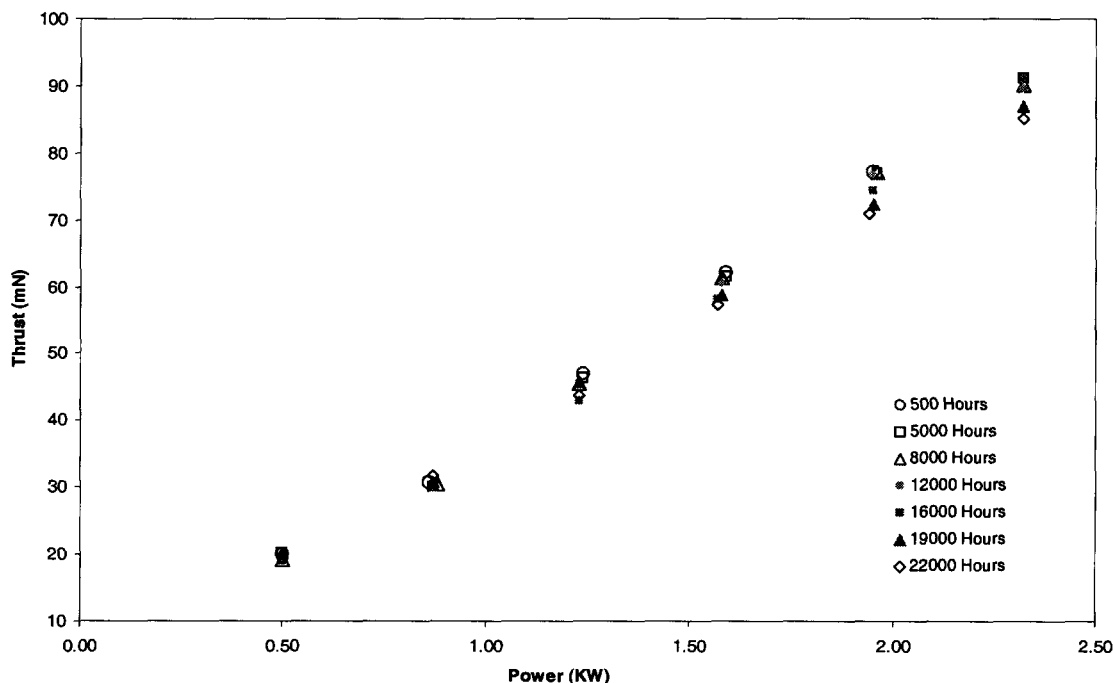
Results of throttling tests over the full power range (see table 1) are shown in Figs. 2, 3 and 4. Fig. 2 is a plot of the measured thrust as a function of thruster power, at several times over the course of the test. Fig. 3 is a plot of specific impulse versus thruster power. The thrust and specific impulse at each throttle point have remained relatively constant over the past 21,000+ hours of operation, with minimal (~ 4%) reduction at the higher power levels, observed from 16,000 to 22,000 hours. The substantially lower specific impulse at the 0.5 kW operating point is primarily due to the lower beam voltage at TH0. The general trend to increasing specific impulse with power is primarily the

Fig. 2 FT2 Thrust Versus Power

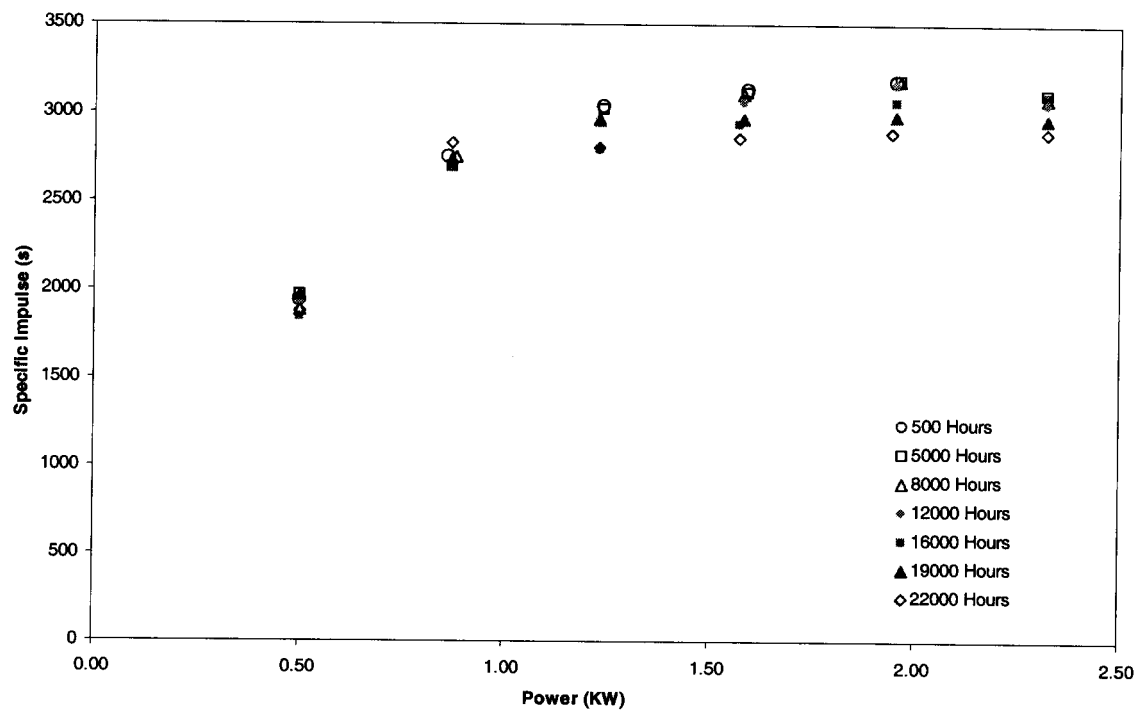
result of reduced cold flow losses through the neutralizer, as power level is increased. At the lower power levels, the un-accelerated neutralizer flow is a higher percentage of the total flow, resulting in lower propellant utilization efficiency. The thrust of an ion thruster is proportional to the product of the beam current and square root of the beam voltage. Similarly, the specific impulse is proportional to the beam voltage. As both beam current and beam voltage are held constant, the thrust level and specific impulse—to lowest order—are also fixed. The minor variation in thrust and Isp, as the thruster wears, is most likely attributed to a slightly higher double ion current in the beam.

Fig. 3 FT2 Specific Impulse Versus Power

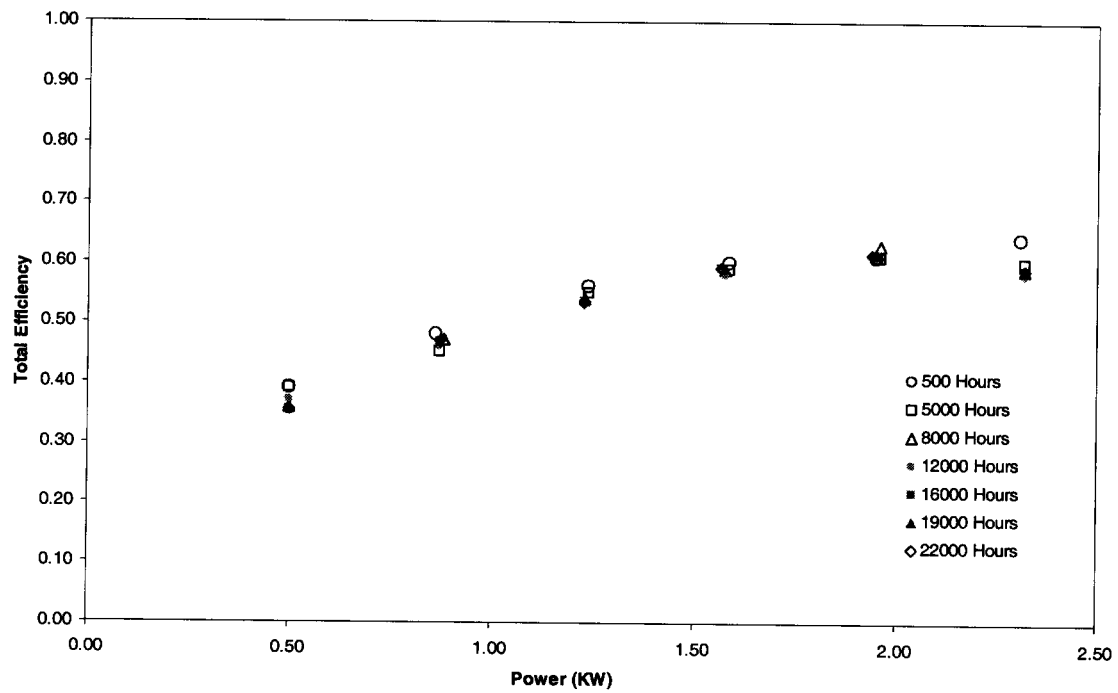
Thruster efficiency is plotted as a function of thruster power in Fig. 4. Thruster efficiency is the ratio of power converted into directed kinetic energy (thrust) to the total power consumed by the thruster. Thruster power is proportional mass flow rate and the square of the specific impulse. The reduced total efficiency at the lower power levels is also a result of more substantial cold flow losses through the neutralizer, in addition to the lower beam voltage at TH0. Variations in thruster power required to produce a given thrust are due primarily to changes in the discharge power as the thruster wears. The total efficiency has also remained relatively constant for each throttle point over the past 22,000 hours. However, an approximate 3% reduction

Fig. 4 FT2 Thruster Efficiency Versus Power

in efficiency has been observed for throttle points TH6 and TH15.

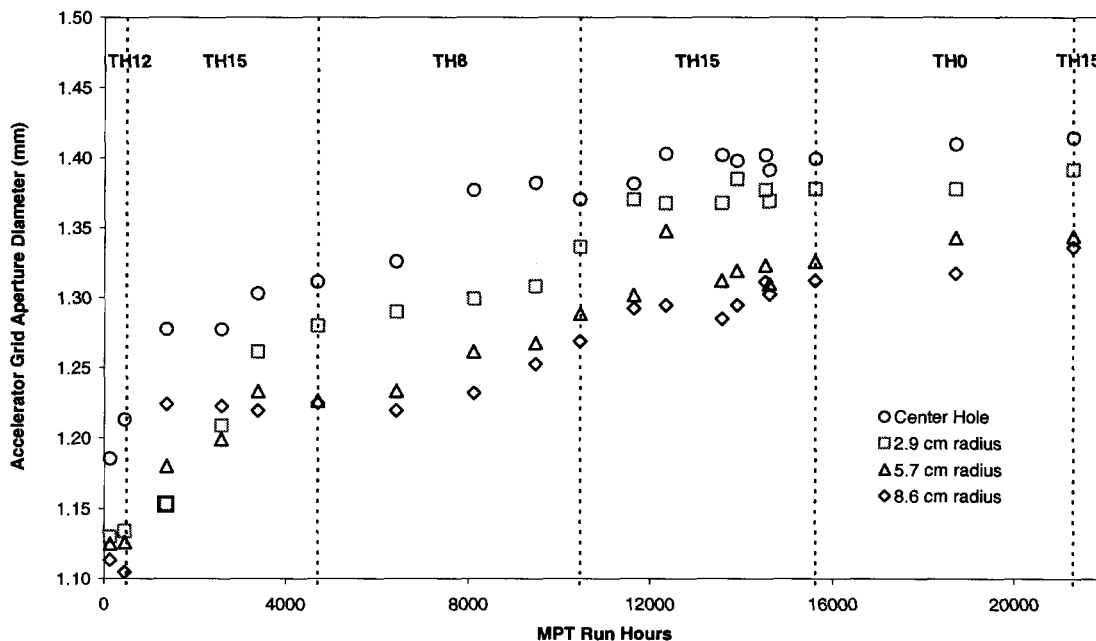
Photographs and video data of the accelerator grid are taken at regular intervals over the course of the test. They are taken at several different radial locations on the downstream face of the accelerator grid. Shown in Fig. 6 are photographs of the center hole of the FT2 accelerator grid from 125 to 21306 hours. In the photograph taken at 125 hours, the cusp from the grid manufacturing process can be seen; however, in the later photographs, the cusp has been eroded away. After 4693 hours of operation, a star erosion pattern is forming around the apertures and a regular pits and groove pattern is being eroded into the webbing between the apertures. Measurements of aperture diameter for four different radial locations are shown in Fig. 5. The measurements have an uncertainty of ± 0.025 mm. The dashed vertical lines indicate the start of a new test segment, and the corresponding power level is shown in between the vertical dashed lines. Data is plotted for diameter measurements taken at the

Fig. 5 FT2 Accelerator Grid Aperture Diameter for 5 different radial locations

center out to 8.6 cm from the center. For the first 5000 hours of FT2 testing, the center hole experienced the most substantial rate of erosion. The other three holes also experienced their highest enlargement rate during the first full power test segment. The rate of enlargement decreased for all four holes during the TH8 segment, and leveled off during the second full power segment. During the TH0 test segment, all holes exhibited a very low aperture enlargement rate. It is important to note, that there is a greater error in the measurements of the outer holes, as the grid is dished, and measurements are being made at a slight angle.¹⁰

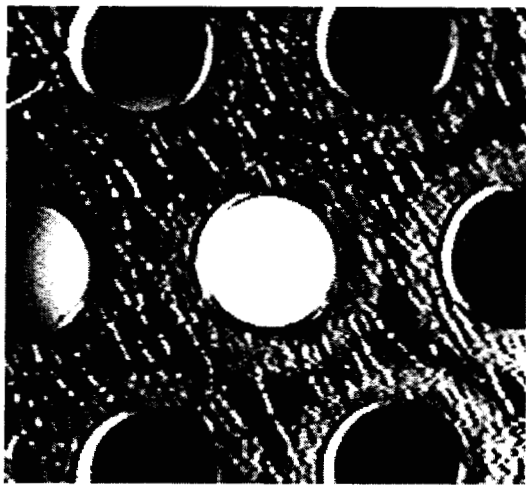
Fig. 6 FT2 Accelerator Grid Aperture Erosion at the Center Hole

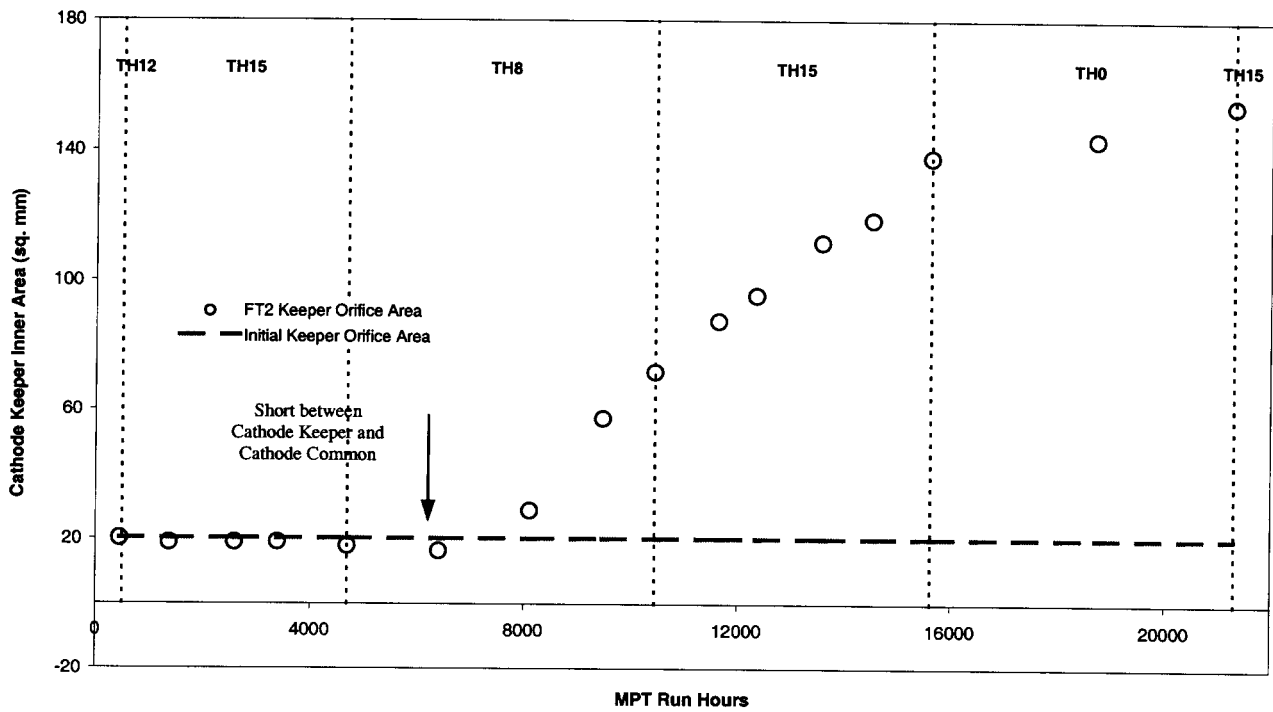
Photographs of the discharge cathode keeper electrode and orifice plate are shown in Fig 9. During the first 4693 hours, at full power, little discharge cathode keeper erosion was observed. The surface of the keeper was pitted, but the diameter of the orifice did not increase significantly. During operation from 4693 to 10451 hours, at TH8, the observed keeper erosion increased significantly, eroding the keeper plate, and exposing the cathode heater region. Full power operation resumed at 10451 hours, and the cathode keeper erosion continued, but at a slightly slower rate. At the end of the test segment, 15617 hours, the cathode heater wire was fully exposed. Operation at the minimum power point (TH0), 15617 to 21306 hours, did not result in any significant cathode keeper erosion or orifice diameter change. Fig. 7 is a plot of keeper inner orifice diameter over time.

Fig. 7 FT2 Cathode Keeper Orifice Area

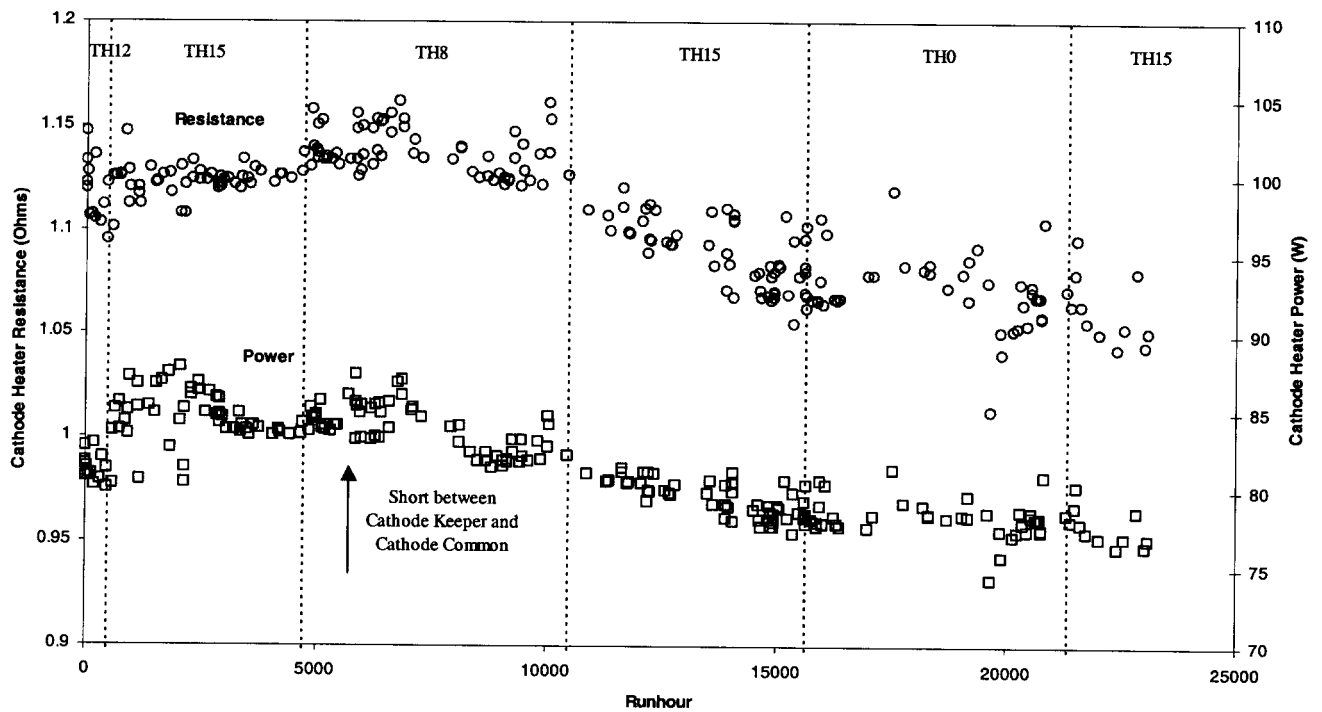
Fig. 8 FT2 Cathode Heater Resistance and Power

In addition to the visual erosion of the keeper surface first observed at ~5000 hours, the discharge cathode heater power and resistance have been decreasing at a steady rate, as is shown in Fig. 8. As the keeper open area has increased, increased radiation from the open area may be responsible for the reduced power. Or it is possible that the eroded keeper material is depositing on the heater or heater wiring reducing the effective resistance of the heater. As of 23,000 hours, the heater power has been reduced by ~6 W from its average beginning of life value. This is critical, because sufficient heater power is required to overcome the work function of the cathode insert, enabling electron emission. The onset of degradation in heater power and resistance also coincides with the cathode keeper to common short, and the increase in discharge keeper erosion. The heater power continued to drop, however, after the short was cleared. Prior to the short, from 447 to 5500 hours, the discharge heater resistance was exhibiting a slight increase with time, a phenomena also occurring with the neutralizer heater to the present day. The reason for this increase is not known.

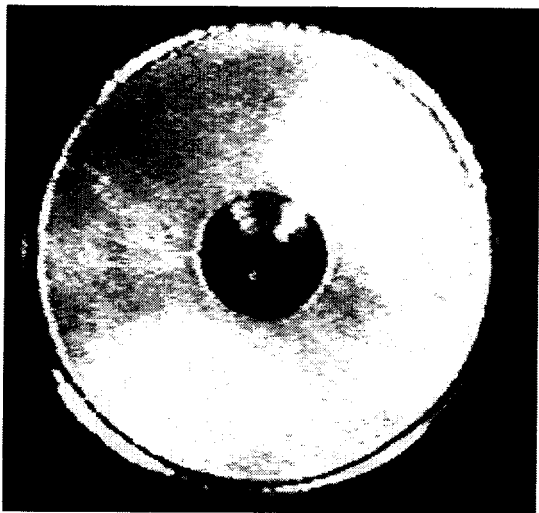
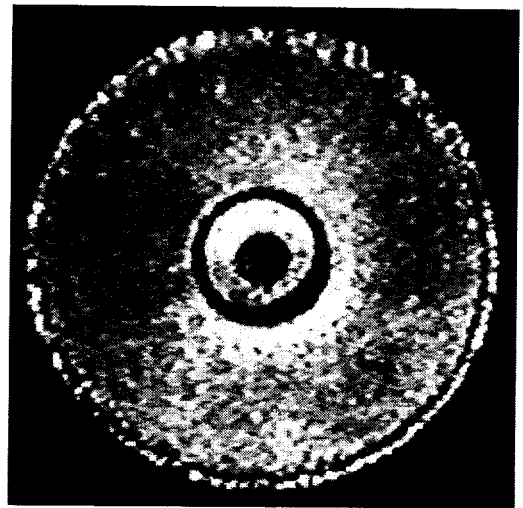
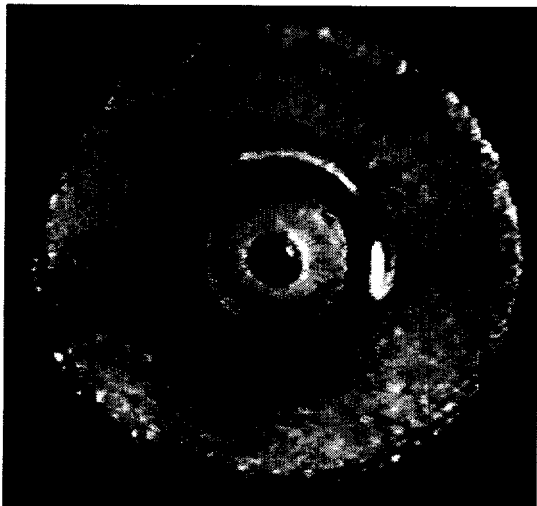
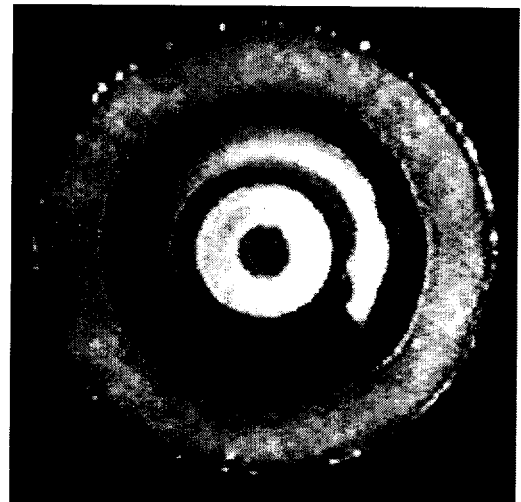
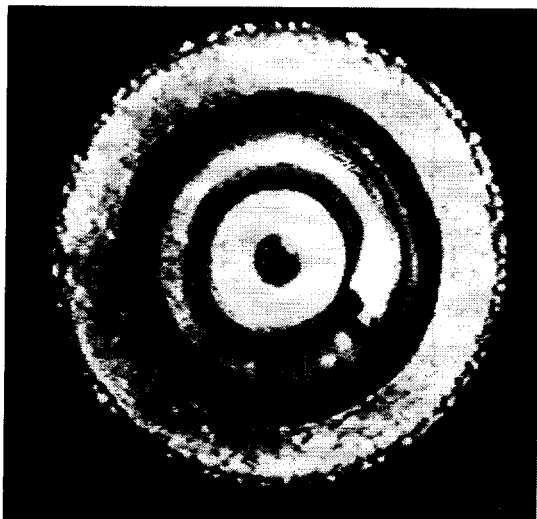
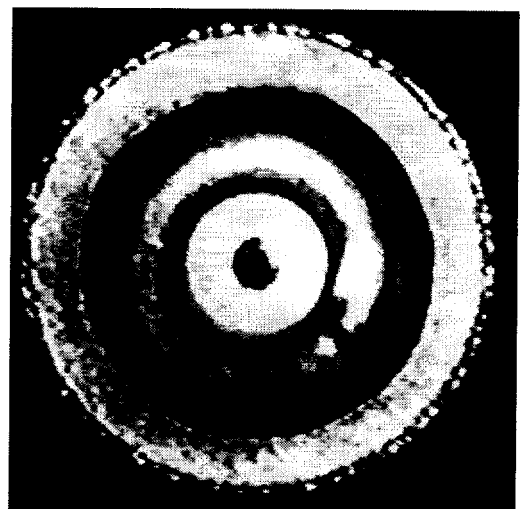
Fig. 9 FT2 Discharge Cathode Keeper Photos

The exact cause and conditions that brought on the discharge cathode keeper erosion are not fully understood at present. Although, the first observation of increase in the rate of erosion coincided with an intermittent short between cathode keeper to cathode common, that occurred at approximately 5850 hours. The voltage between the cathode keeper and cathode common is monitored during thruster operation; typically it is 3 to 5 V. The intermittent short caused the cathode keeper voltage to jump from 3.5 V to ~0.4 V. At 8,873 hours the cathode keeper-cathode common short cleared when the cathode keeper orifice eroded sufficiently. The erosion, however, did proceed beyond this, until the end of the second TH15 segment, at 15617 hours.

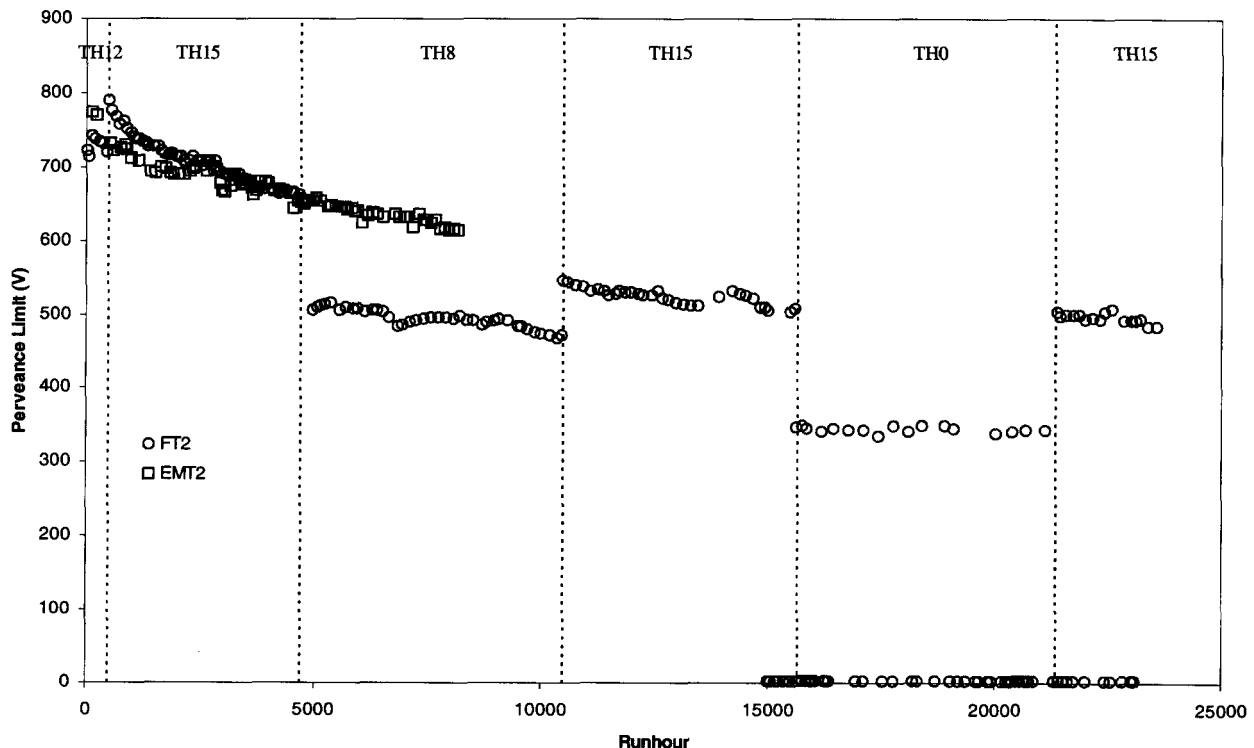
Fig. 10 FT2 and EMT2 Perveance Margin

Fig. 10 shows the change in perveance limit over the course of the test. For EMT2, the perveance limit decreased at the fastest rate during the first 1000 hours. Similarly, the FT2 limit decreased most significantly at the start of the first TH15 test segment. As the thruster wears, the accelerator grid holes enlarge, and as a result the beam must become more de-focused for ions to impinge on the accelerator grid. Therefore as the thruster wears, the perveance limit decreases. As accelerator grid wear decreases with power level, the TH8 and TH0 test segments showed a less significant increase in perveance limit with time.

When operating FT2 at TH15, the perveance limit initially was lower than that of EMT2. But by 2500 hours and until the end of the first FT2 full power test segment, the perveance limits for both thrusters are virtually the same. A shift prior to 124 hours is also noted in the perveance limit data for FT2.²

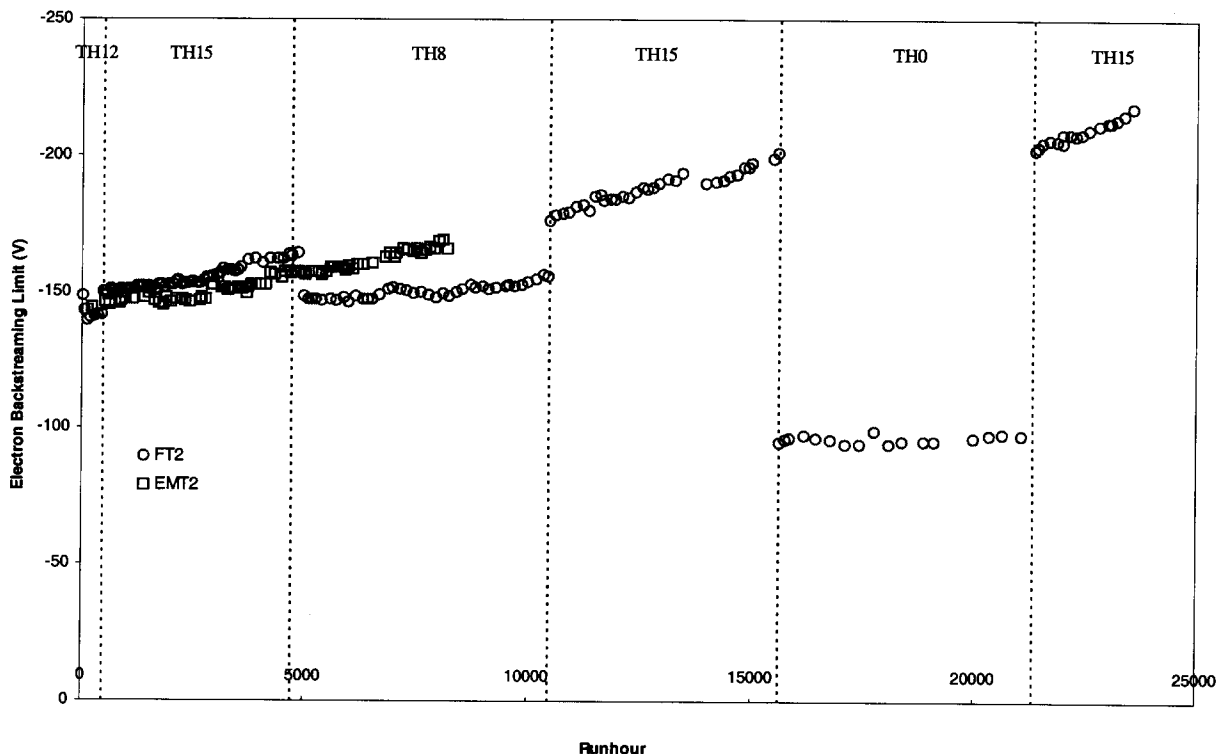
The electron backstreaming limit is determined by increasing the accelerator grid voltage until the discharge loss begins to decrease. Discharge loss is the ratio of energy cost of producing beam ions to the extracted beam current. As stated previously, when backstreaming occurs the positive ion current extracted from the discharge chamber must decrease to maintain the beam current at the set point. As a result, fewer ions are produced in the discharge chamber and the discharge loss decreases. For FT2 testing, the electron backstreaming limit is defined as the accelerator grid voltage at which the discharge loss decreases by 1%. The backstreaming limit is a life-limiting factor for ion thrusters. If the backstreaming limit exceeds the voltage

Fig. 11 FT2 and EMT2 Electron backstreaming Limit

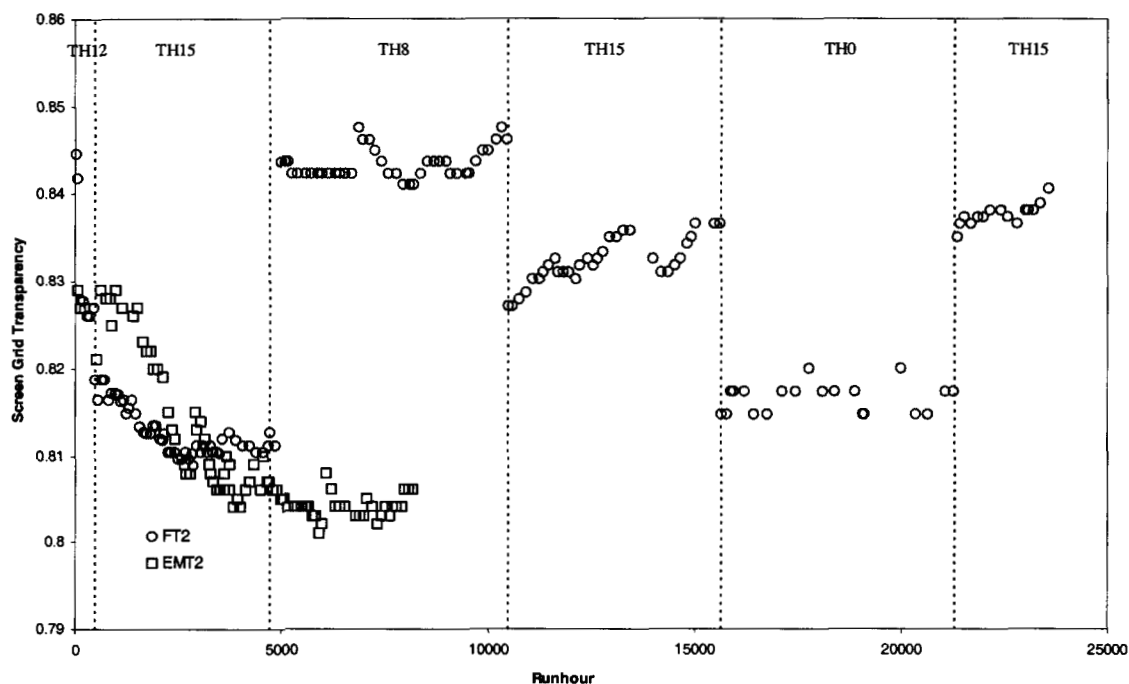
Fig. 12 FT2 and EMT2 Screen Grid Transparency

The shift mentioned previously in the electron backstreaming limit, over the first 124 hours of FT2 testing, is also noted in the transparency data. After this initial shift in screen grid transparency, the transparency measured at TH12 on FT2 and at TH15 during EMT2 testing was comparable. At full power the FT2 screen transparency was less than that of EMT2 up to about 2500 hours. After about 3000 hours, the screen grid transparency for FT2 at full power was slightly higher than that for EMT2. The reason for these differences at full power is not known; however, they may be due to small differences in grid spacing between the two thrusters. After throttling to TH8 the transparency was higher than that observed at TH15 or TH12 after the shift during the first 124 hours of FT2 testing. The transparency remained relatively constant during operation at TH8. When full power operation was resumed at 10,451 hours the screen transparency was higher than during the first full power segment. During the second full power segment the FT2 accelerator grid was biased more negative than during the first full power segment. This results in a stronger electric field between the grids, which facilitates ion extraction—hence the higher screen grid transparency. The screen grid transparency remained relatively constant during the TH0 test segment. This is to be expected, as little change in the grid aperture size occurs at the lower power levels.⁶

Although the observed transparency differences over the course of the test are minor, they do affect discharge chamber performance. A reduction in transparency requires a higher production of ions, to maintain the same beam current. Higher ion production requires more power, thereby reducing thrust efficiency.

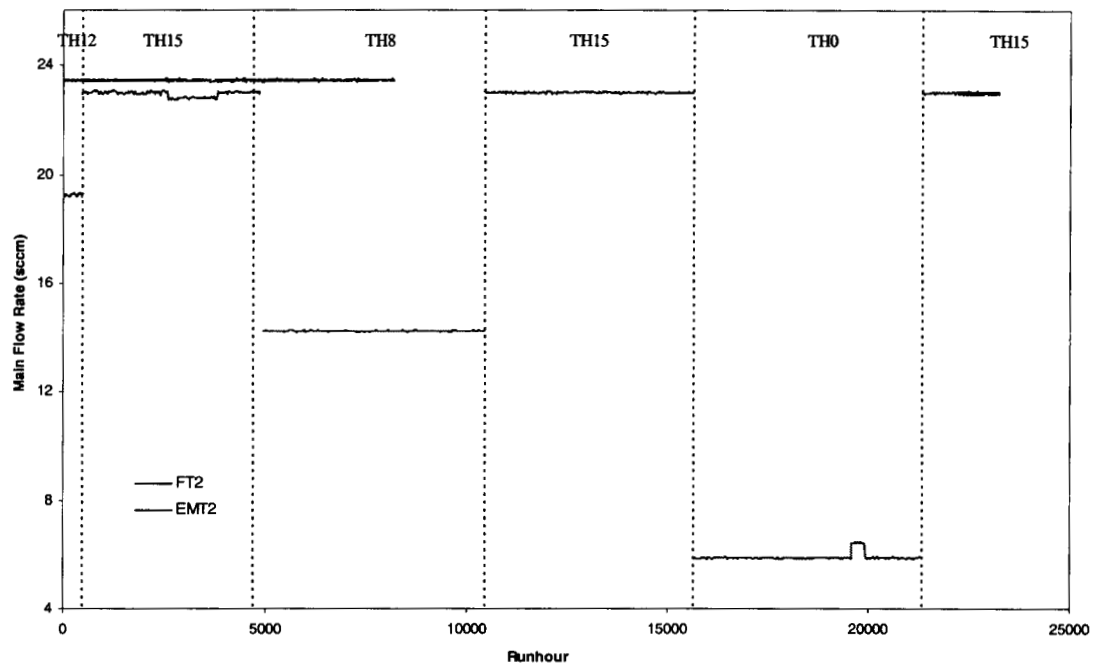
Fig. 13 Main Flow Rate Comparison for FT2 and EMT2

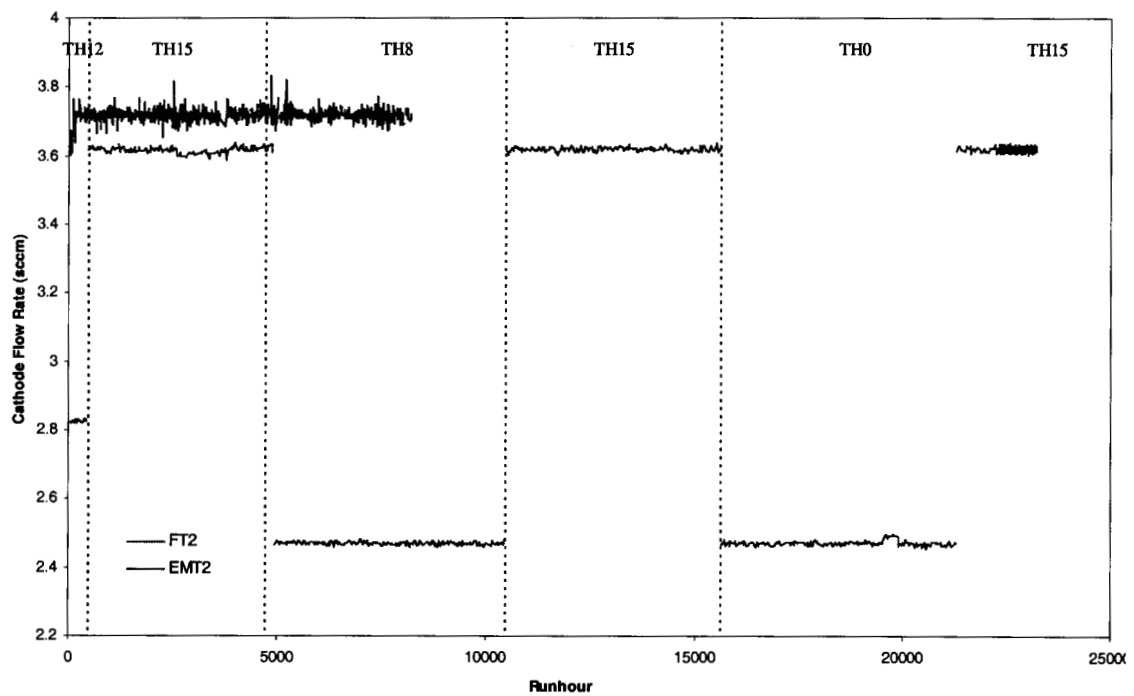
Fig. 14 Cathode Flow Rate Comparison for FT2 and EMT2

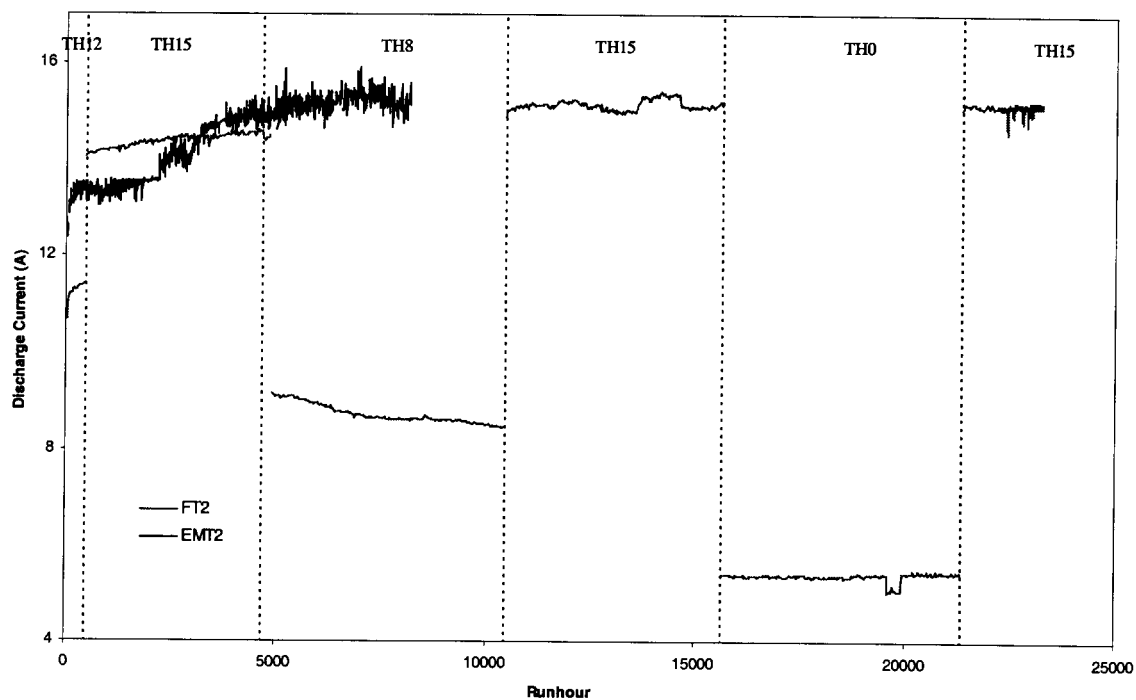
During operation at TH8, the half power point, the discharge current decreased approximately 0.68 A, over 5509 hours of operation. The cause for this decrease is not known at this time, although this rate of decrease does correspond to the short that developed between the cathode keeper to cathode common, resulting in a 3 volt drop in cathode keeper voltage. The rate of discharge voltage increase rose over this interval until the discharge current became relatively constant.

Operation at the full power point resumed over 10455 to 15617 hours. At the start of this test segment, the discharge current was 0.38 A higher than the end value at the previous full power segment. At the start of this test segment, the discharge current was 0.38 A higher than the end value at the previous full power

Fig. 15 Discharge Current Comparison for FT2 and EMT2

segment. During this interval the discharge current increased 0.28 A, corresponding to a lower rate of neutral loss. Operation at TH0 showed virtually no change in discharge current over its 5663-hour interval. This corresponds to the absence of accelerator grid enlargement at this power level.

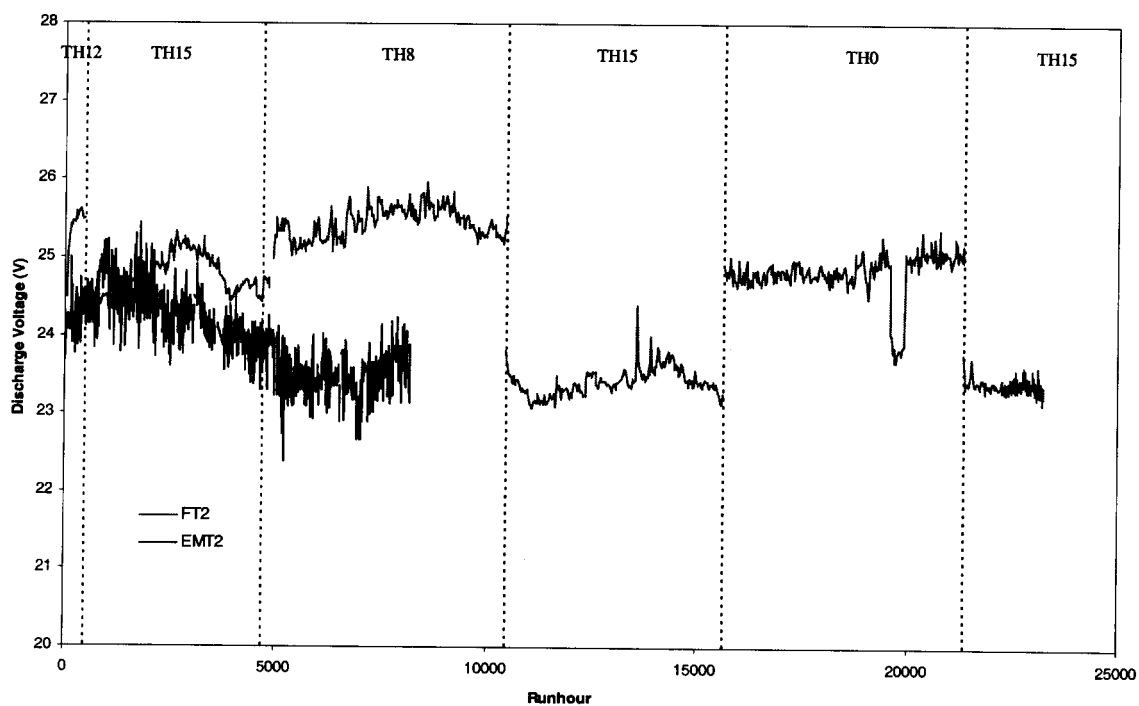
Fig. 16 Discharge Voltage Comparison for FT2 and EMT2

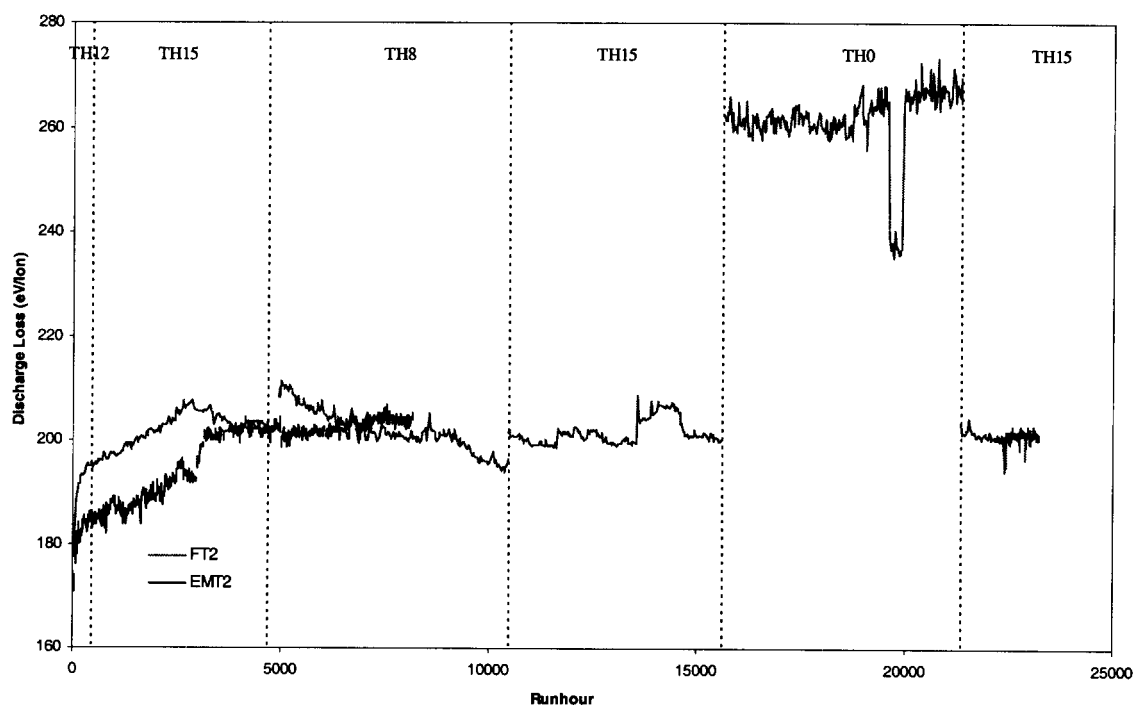
Fig. 17 Discharge Loss Comparison for FT2 and EMT2

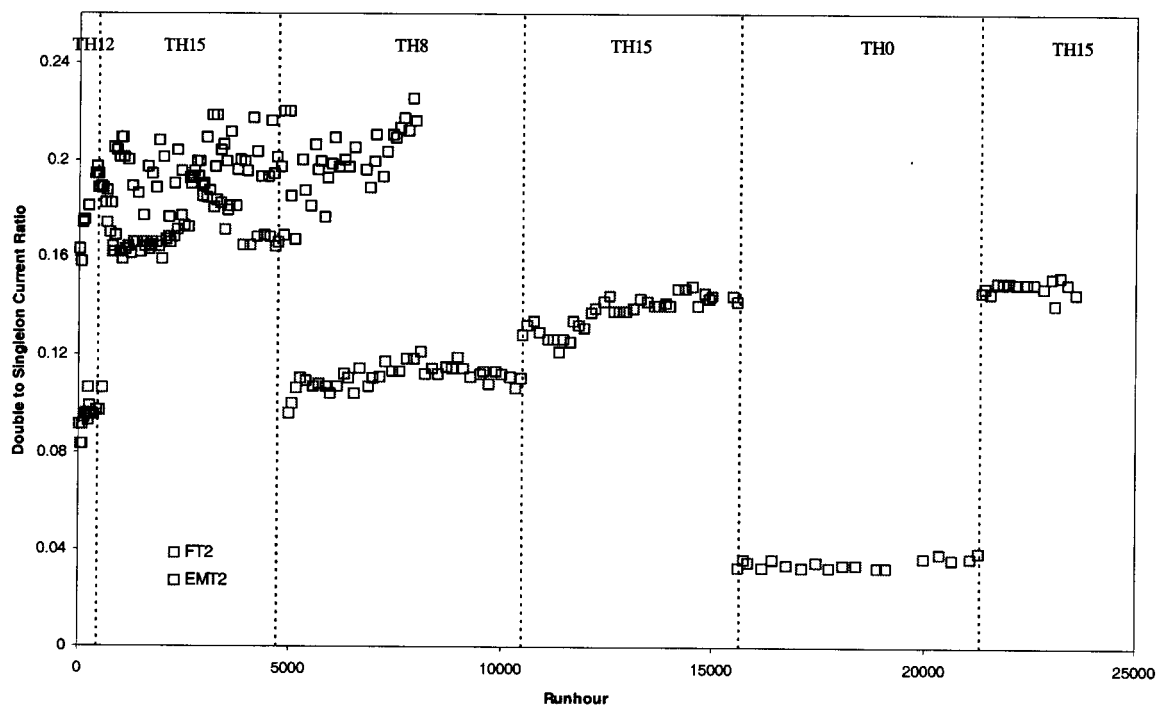
Fig. 18 Double to Single Ion Content Ratio Comparison for FT2 and EMT2

The double-to-single ion current ratio is shown in Fig. 18 for FT2 and EMT2. The variation between the EMT2 and FT2 doubles ratio is thought to be primarily due to the alignment of the FT2 ExB probe. At the start of FT2 testing, the ExB probe was initially aligned to provide maximum single ion current. However due to the shift in the ion optics observed after 124 hours of operation, it is likely the probe is no longer in the location of maximum singles current, resulting in a reduction of the measured doubles current for FT2. In addition, the probe used for EMT2 testing accepted more ions than the FT2 probe. This would further increase the measured double-to-single ion ratio, for EMT2, if a higher percentage of the doubles were produced near the thruster centerline.

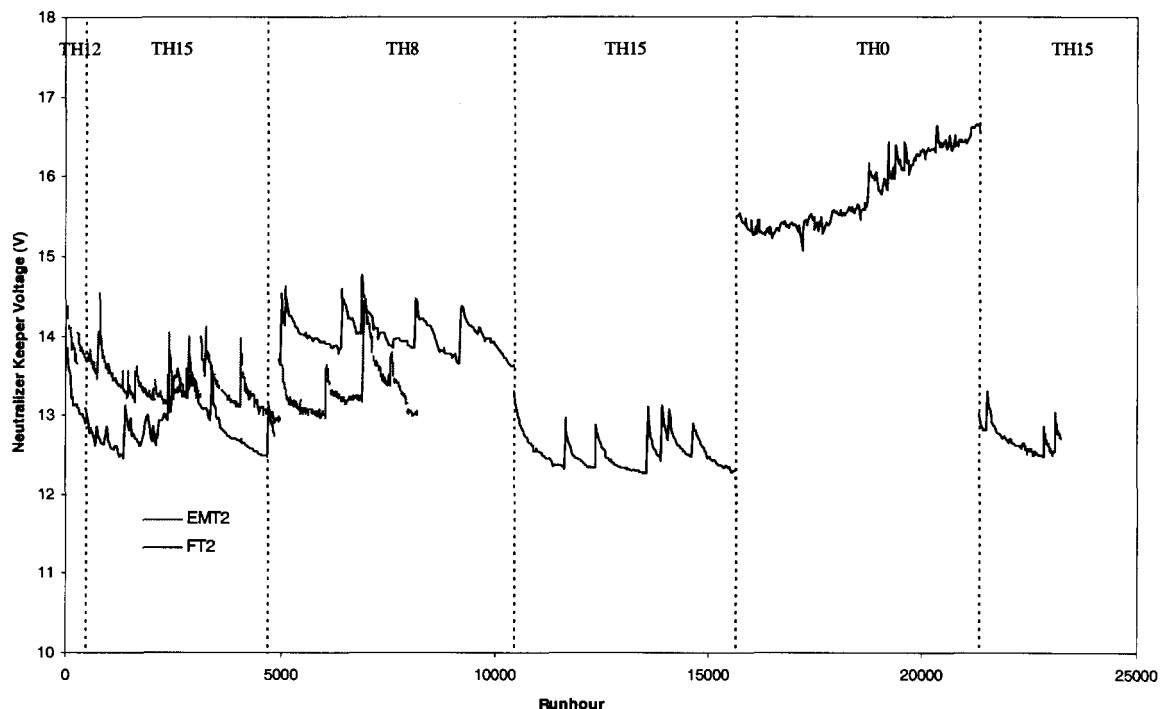
Fig. 19 Neutralizer Keeper Voltage Comparison for FT2 and EMT2

An interesting trend was observed during operation at TH0, the minimum power point. The neutralizer voltage began to steadily increase over that 5000-hour test segment. This trend was not observed during the TH15 or TH8 test segments. Further inspection of photographs of the neutralizer orifice during this test segment reveals the formation of deposits within it, reducing its effective area. This will be discussed in more detail shortly. Additionally, when the thruster returned to full power operation after 21,306 hours, the neutralizer keeper voltage returned to its nominal operating voltage, showing no signs of the previous test segments rate of increase.

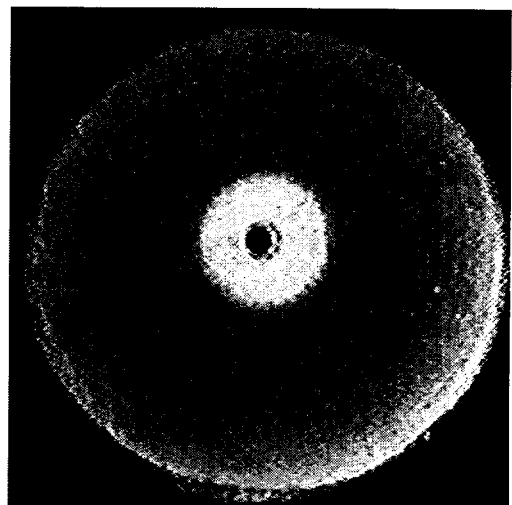
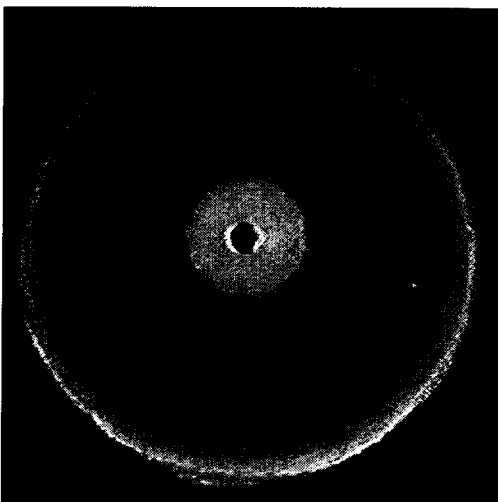
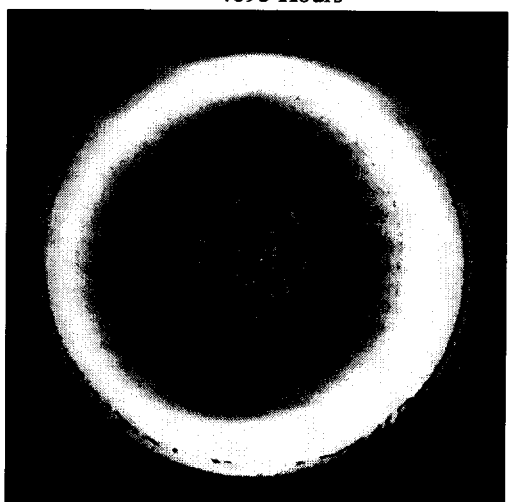
Fig. 20 is a set of photographs of the neutralizer keeper and orifice, backlit by its heater. These images are used to monitor any neutralizer keeper erosion, and to measure the change in orifice diameter over time. During operation at the first full power segment no noticeable erosion of the keeper was observed, however a small reduction in orifice diameter was observed. Operation at TH8 and the second full power test segment did not result in any further keeper erosion and the rate of orifice change was minimal. During operation at TH0, the minimum power point, significant deposition of material began to form within the orifice. It is not possible to determine the exact location of these deposits, whether they are in the downstream or upstream end of the orifice, from the images. Fig. 22 is a plot of the orifice diameter over time. By the end of 21,306 hours of operation, the measured area of the orifice is 40% of the initial size. This phenomenon is the most probable cause of the increasing neutralizer keeper voltage also observed during operation at TH0.

Fig. 20 FT2 Neutralizer Cathode Photos

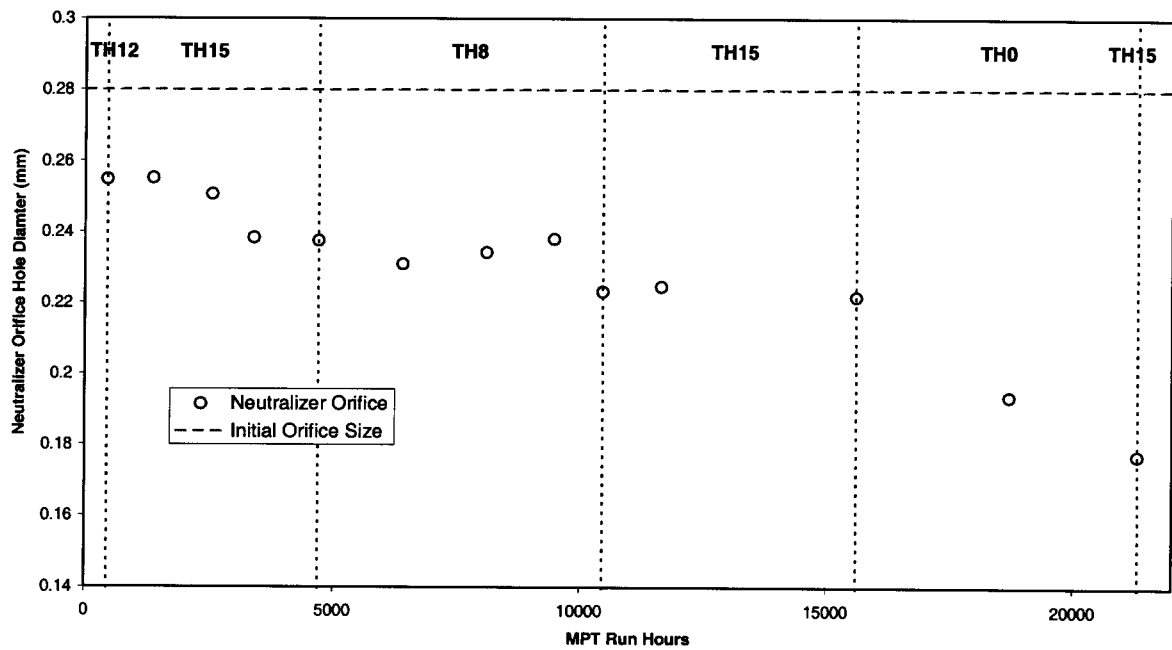
Fig. 22 FT2 Neutralizer Cathode Orifice Diameter

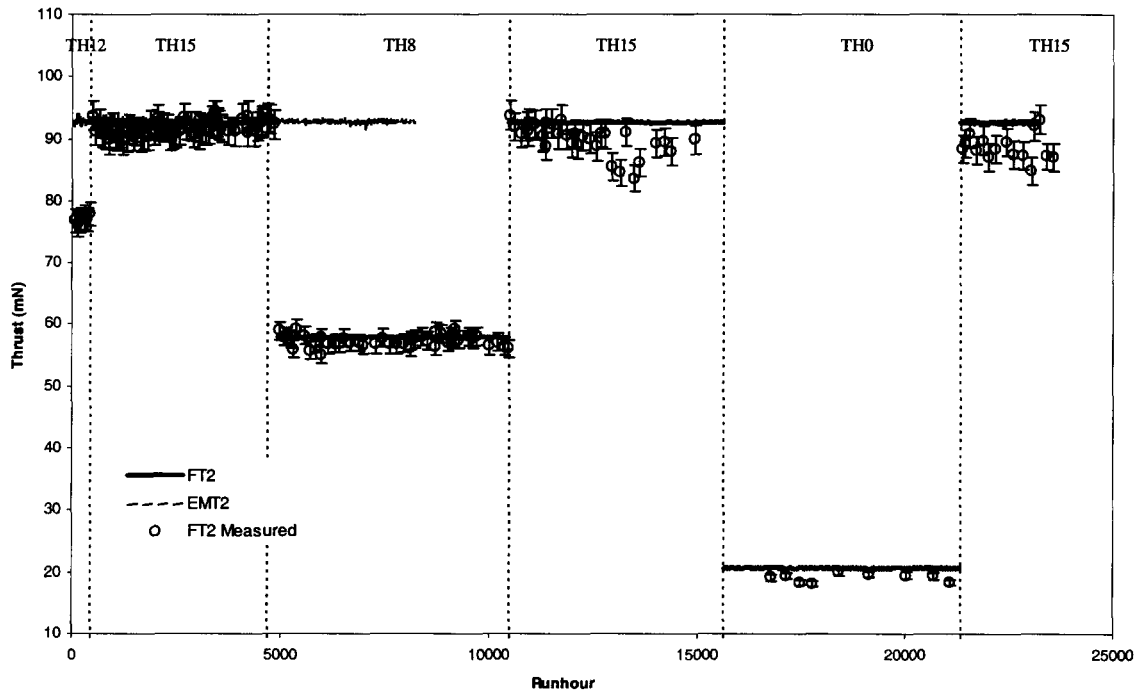
Fig. 23 Thrust Comparison for FT2 and EMT2
